WOOD DESTROYING PESTS AND ORGANISMS INSPECTION REPORT

Building No. 1234	Street Main Street	City Hometown	Zip 90210	Date of Inspection 05/05/2005	Number of Pages 1 of 7
----------------------	-----------------------	------------------	--------------	----------------------------------	---------------------------

Report #: 50717

Complete Inspection Report

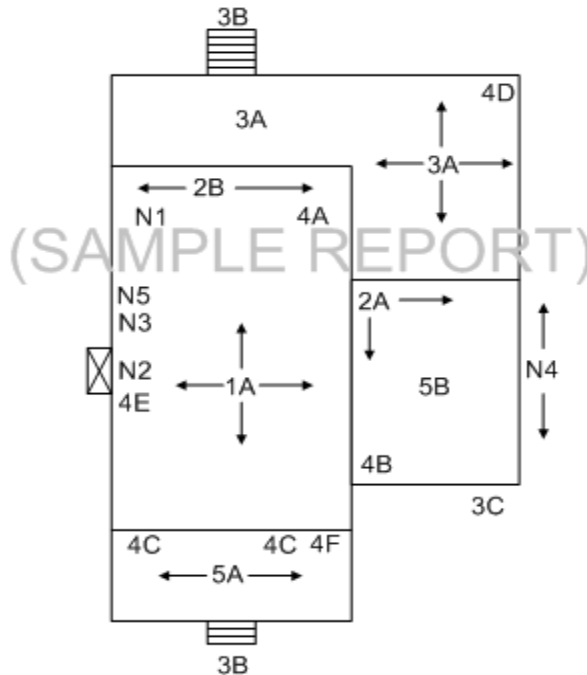
(Diagram not to scale, finding locations approximate)

Finding: 1A Evidence of Subterranean Termite infestation was found at the cellulose desbris in the crawl space and indicates an infestation in the soil below the structure.

Finding: 2A Evidence of Drywood Termite infestation was found in wood members of the garage wall framing and appears to extend into inaccessible areas of the structure.

Finding: 2B Evidence of Drywood Termite infestation was found in the attic framing and appears to extend into inaccessible areas of the structure.

Finding: 3A Fungus infection and damage were found in the wood deck in the decking and framing.

Finding: 3B Fungus damage was found in both sets of wood steps. Damage has occurred due to earth to wood contact.

Finding: 3C Fungus damage was found at the garage door frame.

Finding: 4C Carpenter bee infestation was found in the fascia.

Finding: 4D Wood boring beetle infestation was found in the deck post.

Finding: 4E Carpenter ant infestation was found in the attic space.

Finding: 4F Dampwood Termite infestation was found in the deck framing adjacent to the wood siding.

Finding: 5A The area beneath the front wood deck was inaccessible for inspection due to low clearances. Infestation or infection appear to extend into this inaccessible area.

Finding: 4A The stall shower was found to be leaking after a standard water test was performed. This leakage occurs due to damage and/or deterioration of the waterproofing beneath the tile and concrete.

Finding: 4B An excessive moisture condition exists due to leakage at the water softner supply line.
Recommendation: Replace the water softner supply line to eliminate the excessive moisture condition.
Price: \$85.00

Finding: 5B The attic space above the garage was inaccessible for inspection due to lack of an adequate access opening.
Recommendation: Install an access opening, reinspect and submit further findings and recommendations on a supplemental report. Cost for reinspection and report will be \$50.00 if access is installed by others.
Price: \$115.00

Recommendation: Chemically treat the soil in areas of Subterranean Termite activity using Termidor (fipronil). In addition, an application will be made to the soil adjacent to the exterior wall around the complete perimeter of the structure. Holes may be drilled through concrete, paving or masonry adjacent to the foundation in areas such as, but not limited to; patios, sidewalks, porches and driveways, to allow for chemical treatment of the soil below. We will exercrise reasonable caution when drilling but assume no liability for damage to hidden plumbing, electrical, or other utility below these areas. The location of such utilities should be identified prior to our arrival. Regardless of locations of Subterranean Termite infestation found, control of the entire structure is guaranteed. Control is guaranteed by Key Termite and Pest Control for a period of 5 years from the date of treatment.

Recommendation: Seal the structure and fumigate with Vikane fumigant (Sulfuryl Flouride) . All occupants and pets must vacate the structure until the fumigation is complete. This company will exercise all due caution, but cannot be held responsible for damage to plants, TV antennas or roofing due to the fumigation. Further terms and instructions will be supplied upon request or upon scheduling of the fumigation. Information may also be obtained from the fumigation page on our website at www.keytermite.com *****Fumigations are guaranteed for 5 years from the date completed*****

Recommendation: Remove and replace the damaged portions of woodmembers of the deck as needed to eliminate the fungus infection. In areas where VERY MINOR fungus growth is present, but no detectable deterioration has occurred, scrape away the surface growth with a wire brush and chemically treat the woodmembers with Tim-Bor (Disodium Octaborate Tetrahydrate) for elimination of infection. Repair includes replacement of wood members with similar materials (unless improper materials were originally used). Note: Price quoted above does not include complete replacement of the wood deck. Additional damages may be discovered when concealed surfaces of wood members are exposed during the course of repairs. If further damage is discovered, additional costs will apply.

Recommendation: Replace the damaged portions of wood members of the steps as needed. Lower soil to eliminate the earth to wood contact. Price included in item 3A above.

Recommendation: Replace the damaged portions of the door frame as necessary.

Recommendation: Chemically treat the wood members showing signs of carpenter bee infestation with Drione (amorphous silica, pyrethrins, piperonyl butoxide). Seal entrance holes with brass wool and latex caulking.

Recommendation: Remove and replace the deck post to eliminate the infestation. Price included in item 3A.

Recommendation: Chemically treat the wood members showing signs of carpenter ant infestation with Termidor (fipronil).

Recommendation: Chemically treat the infested wood members using Termidor (fipronil). Dampwood Termites will only infest sound wood when there is an adequate moisture source. Such moisture condition should be controlled if possible.

Recommendation: Remove two boards every six feet of the top decking to allow for further inspection. Reinspect and submit further findings on a supplemental report. Note: Damage may occur to the decking as a result of the decking removal. Additional costs will apply, if necessary, when decking is reinstalled by this company. Cost for reinspection and report will be \$50.00 if decking is removed and reinstalled by others.

Recommendation: Contact a licensed tile contractor to perform this repair. Repair should include a minimum of the following; Removal the floor of the shower and two frames of tiles up the wall and over the dam; Replacement of the shower drain if needed; Installation of a new vinyl pan and retiling of the base of the shower. Contact our office to reinspect inaccessible wood members after the shower pan has been removed by the contractor and before new wood is installed. A supplemental report will be issued with further finding and recommendation. Inspection and report fee will be \$45.00.
